SERVICE BULLETIN

24.08.06

Following reports from the field regarding failures of TSE disc type springbrakes, it has been discovered that not all drainage plugs are being removed from new brake chambers when fitted to axles.

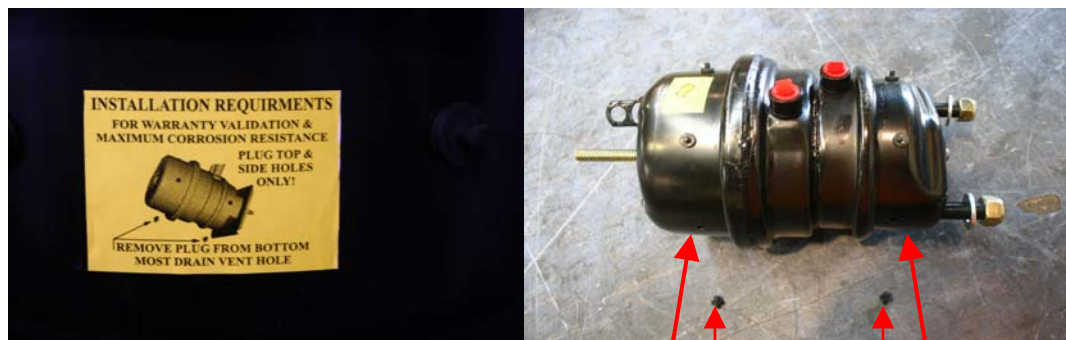
Photos below show the label attached to each new chamber reinforcing this requirement, and location of plugs referred to. This requirement also applies to service chambers.

These are the plugs referred to and where they came from.

Chambers are shipped with all drain holes plugged as it is not possible to know final chamber orientation until fitted. Once fitted, the lowermost plug on each section, **must be removed**. Failure to do so invariably results in premature failure of the chamber.
